NAND Design-In Notice

1. Introduction

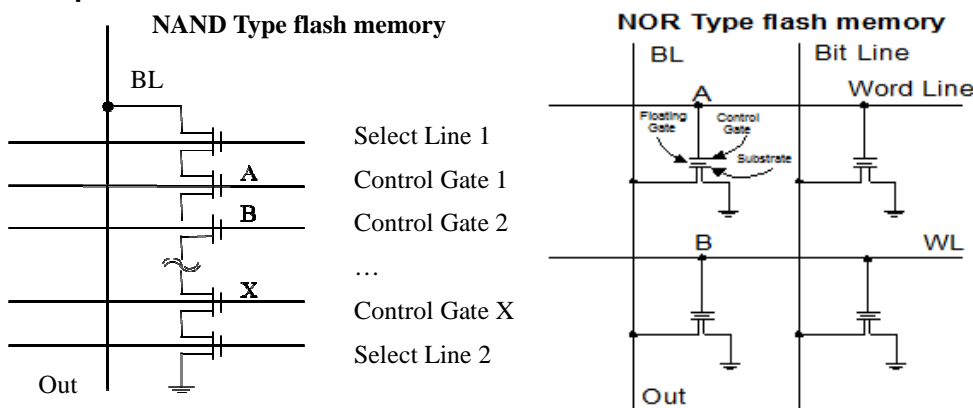
Figure 2-1: Comparison of NAND and NOR Cell Structure

In NOR flash, memory cells are independent, but NAND memory cells are joined together to form strings of 32 or 64 cells. See Figure 2-1: Comparison of NAND and NOR Cell Structure. With this structure, a NAND memory cell may become dependent on other member cells of its string. Weak cells in a string may prevent data from being programmed into a cell, prevent cell erasure, cause cell read bit errors that exceed specifications, and so on. Every flash vendor has its own screening method to identify defective cells in a block and mark that block as BB (Bad Block) if the defective cells cannot be corrected with ECC. In general, NAND flash will not ship if the BB count exceeds 2% of the total number of blocks.

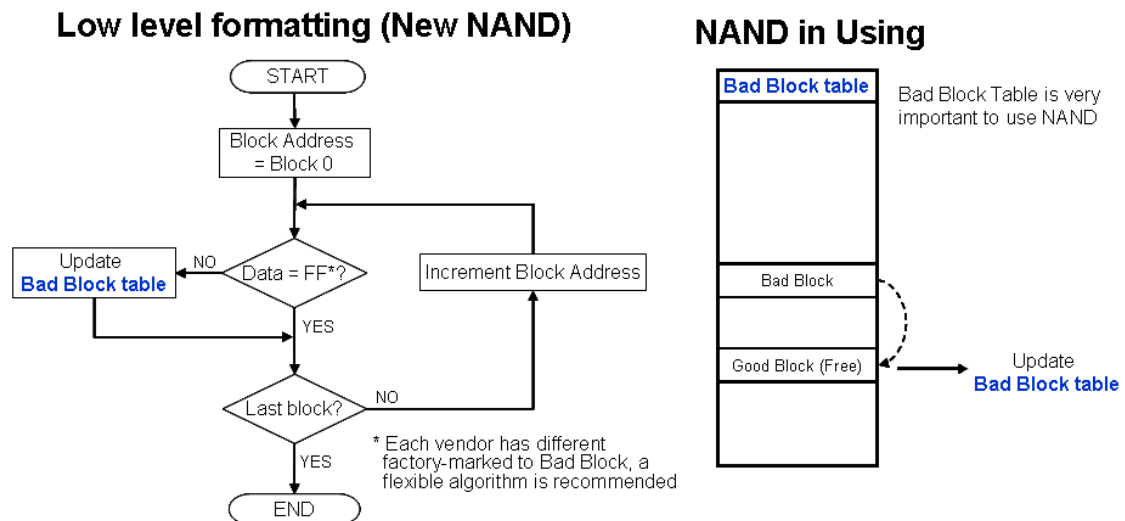
Bad blocks (BB) are common in NAND flash, and they must be handled correctly by software. When a user accesses a fresh NAND device for the first time, it is important to scan all bad block markers and build a BBT (Bad Block Table) in order to prevent using any of the bad blocks listed in the BBT. Additional bad blocks may be found during normal NAND usage, and they should be handled by BBM (Bad Block Management).

Software is necessary to achieve block management with NAND Flash designed into a system, and it also needs to provide the ECC function if the Host Processor does not support hardware ECC. Additionally, Bad Block Management(BBM) is a must-have to provide data storage integrity of NAND Flash and to maintain the Bad Block Table(BBT). See Figure 2-3: BBM – BB Scan and BBT is one of common methods being used by BBM. It supports NAND flash usage by the Host Processor in system. It also stores and builds up a backup table in initial good block. It not only keeps NAND initial bad block information, but it also records bad block replacement during NAND usage.

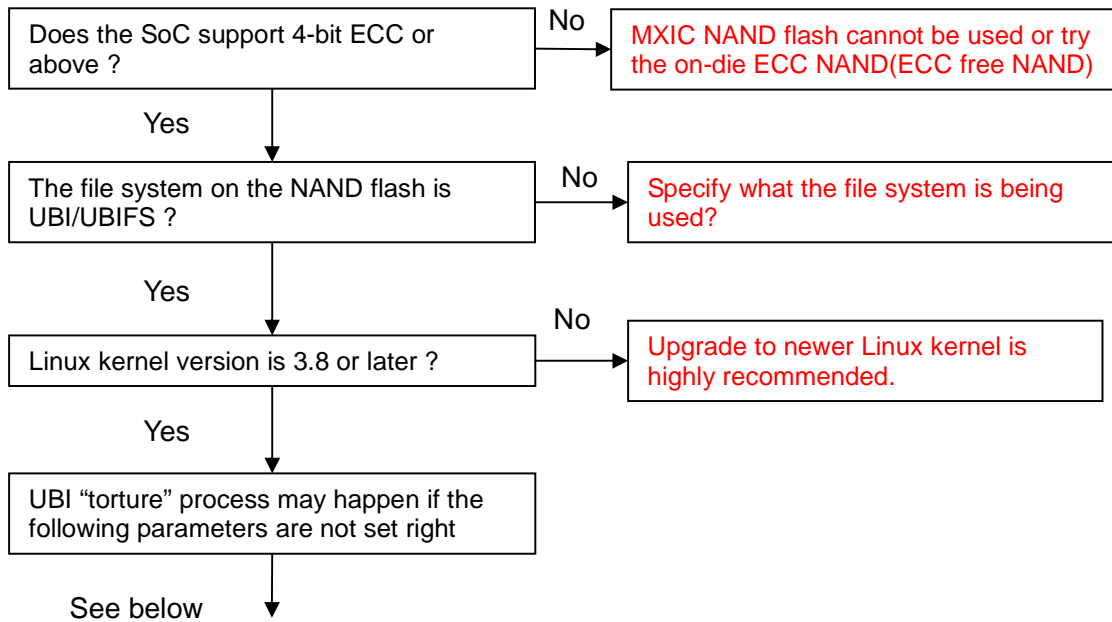
5-1. UBI/UBIFS File System for Usage Example

The following is the checking diagram that the user must go through to make sure the target system can work smoothly with our NAND flash.
